FINAL COMPLETION REPORT For

COLD FOAM IN PLACE RECLAMATION Col-20 PM 10.2-28.2

North Region Materials Marysville, CA August 2006

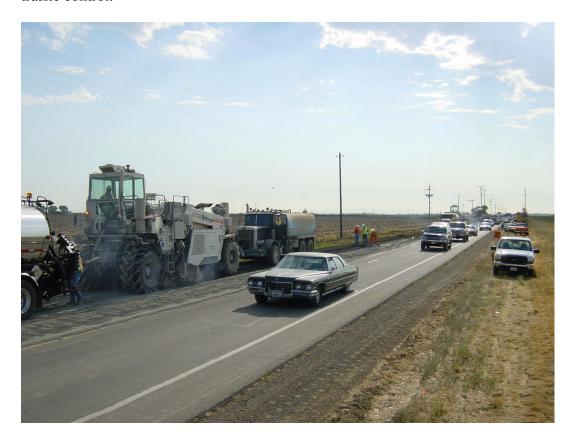
Two recycling trains were utilized. One recycling train consisted of:

3000-Gallon Bitumen Truck.
10' Recycler with foam bar.
3000-Gallon Water Truck.
One Vibratory Pad-Foot Roller
One Motor Grader
One Tandem Axle Steel Drum Roller
One Pneumatic Tired Roller

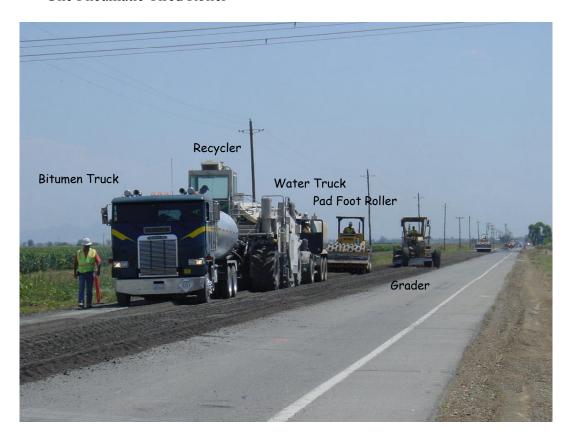
The second recycling train consisted of:

3000-Gallon Bitumen Truck. 8' Recycler with foam bar. 3000-Gallon Water Truck. One Vibratory Pad-Foot Roller One Motor Grader One Tandem Axle Steel Drum Roller One Pneumatic Tired Roller
